**TAUNTON RIVER BASIN
FOXBOROUGH, MASSACHUSETTS**

**LAKE MIRIMICHI DAM
MA 00168**

PHASE I INSPECTION REPORT NATIONAL DAM INSPECTION PROGRAM

Date of Inspection: December 5 and 6, 1978

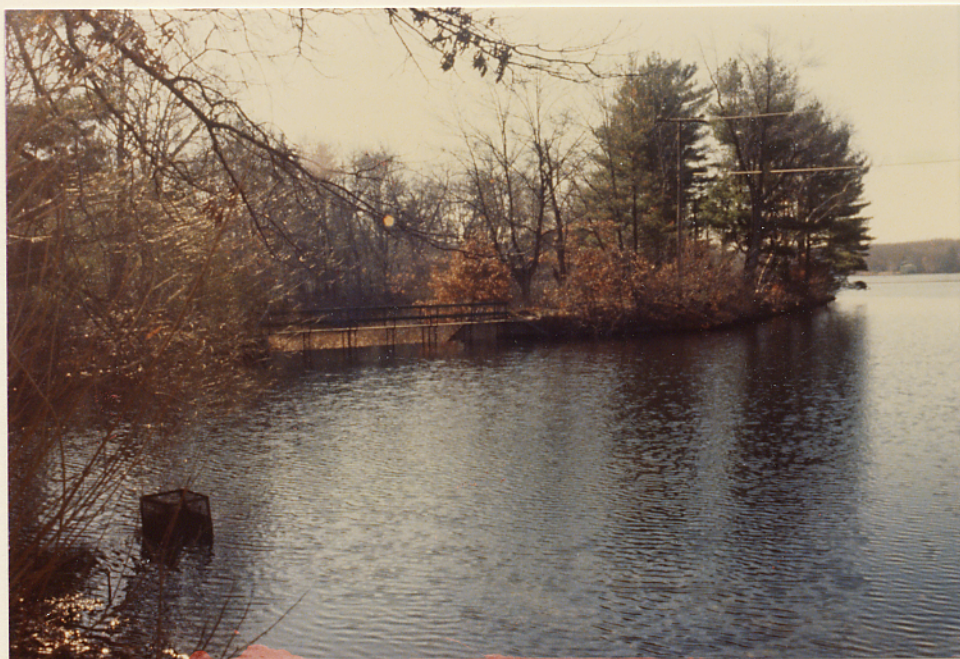
NO. 1 VIEW OF SPILLWAY AND EMBANKMENT

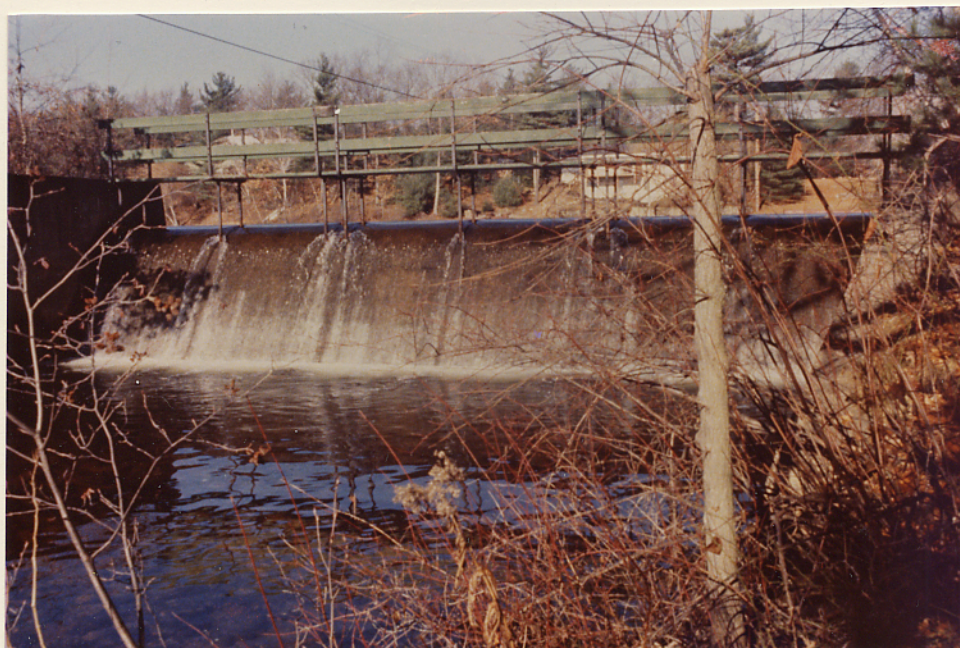
- c. Appurtenant Structures. The spillway is a concrete, ogee weir with a stilling basin at the toe. The spillway is in fair condition. The concrete facing of the weir is spalled and there are many irregular, horizontal cracks. Most vertical cracks are aligned with the metal posts used to support the wooden footbridge. There is one vertical crack located between support posts. The wooden footbridge spanning the spillway contains two boards which are rotting. The bottom of the metal support posts for the bridge are rusted. The downstream end of the right training wall is spalled. There is some erosion of both training walls below the high water mark. There is also a vertical crack in each training wall near the footbridge. At the time of inspection, water was flowing over the crest. The stilling basin is covered with stones and at the time of the inspection was submerged. The downstream channel is relatively clear of debris, but the sides of the channel contain a heavy growth of cattails and other vegetation. The bottom of the channel is a natural streambed containing loose stones.

*cracks. Horizontal cracks are irregular. Vertical cracks at walkway support struts, including one vertical crack between struts.

NO. 2 VIEW OF SPILLWAY

- (2) Fill in eroded areas on the downstream face of the dam.
- (3) Repair spalled and cracked concrete on the crest and training walls of the spillway.

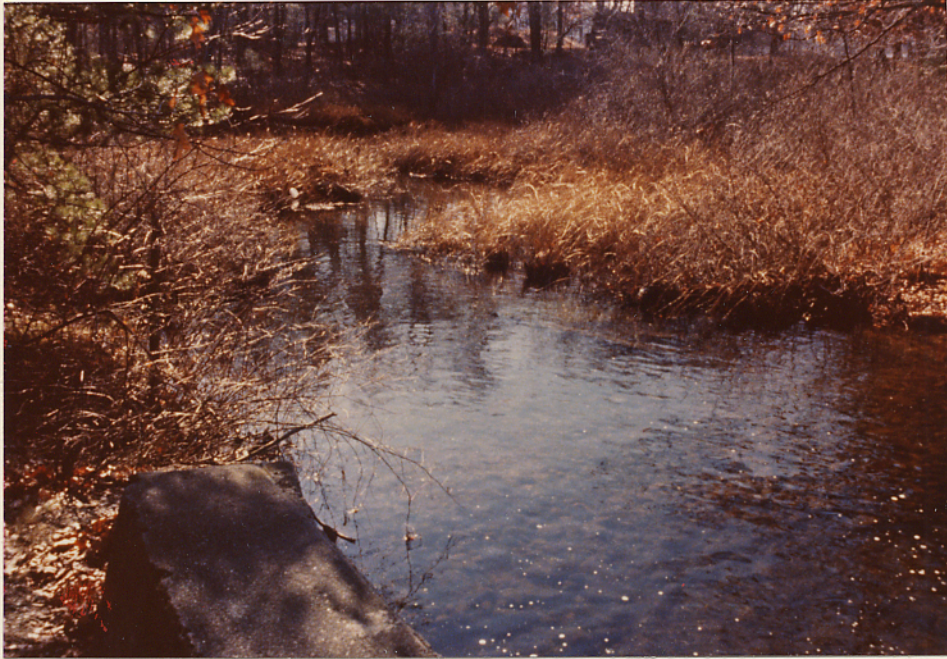
c. Discharge Channel	
General Condition	Good, clear, no visible obstructions.
Loose Rock Overhanging Channel	None
Trees Overhanging Channel	A few bushes & small trees
Floor of Channel	Clear, flat, cobble and stone bottom.
Other Obstructions	Relatively clear, few clumps of brush.

NO. 3 VIEW OF SPILLWAY DISCHARGE CHANNEL

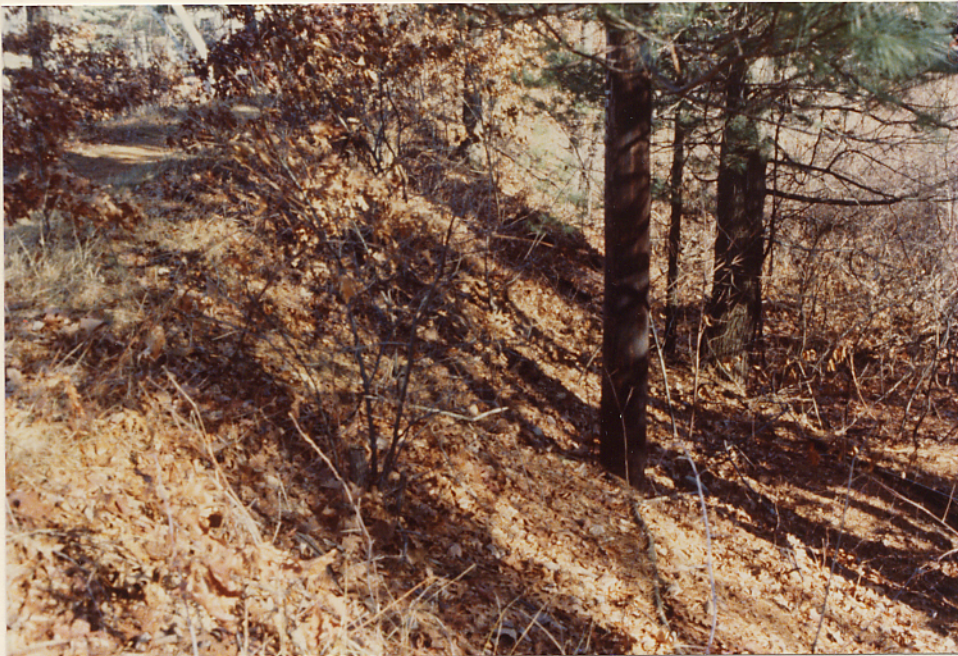
- b. Dam. The dam is a 620-foot long, 14-foot high earthfill embankment. In general, the dam is in fair condition. There is a large pool of relatively clear water at or near the downstream toe of the dam along most of the embankment south of the spillway. This is a low area inundated by discharge from the spillway and outlet pipe. The elevation of the pool is at El 152.7. At the toe of the embankment north of the spillway there are two distinct seepage areas. The first area is about 50 feet northeast of the spillway, and the surface of the clear standing water is at El 154.5. The second seepage area is located about 70 feet south of the cabin and although there is no standing water, this area is wet, soft, and covered with trash and debris.

NO. 4 VIEW OF DOWNSTREAM SLOPE OF DAM

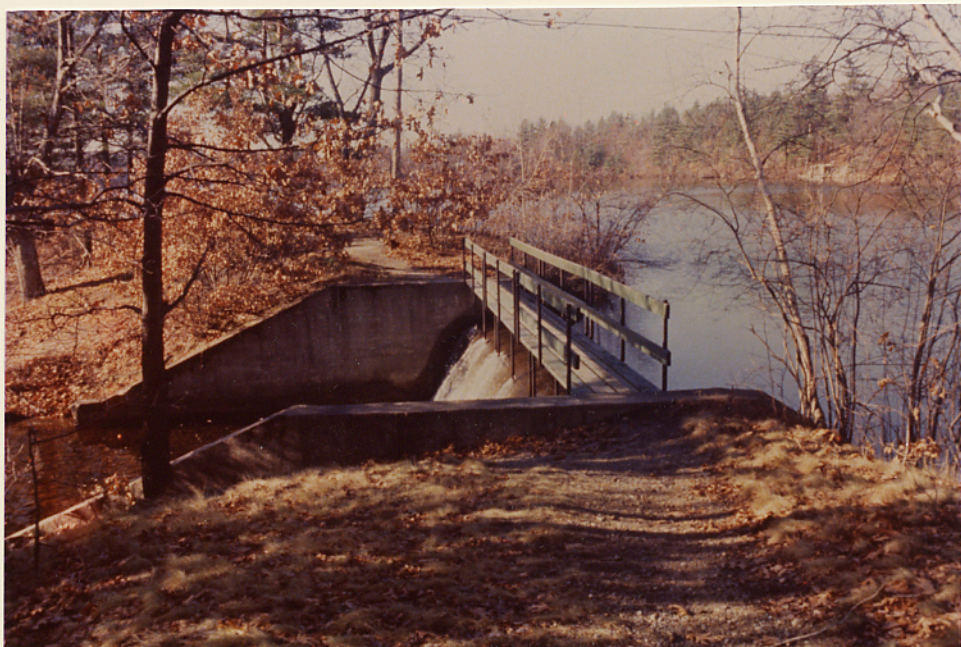
NO. 5 VIEW OF WEST CREST OF DAM

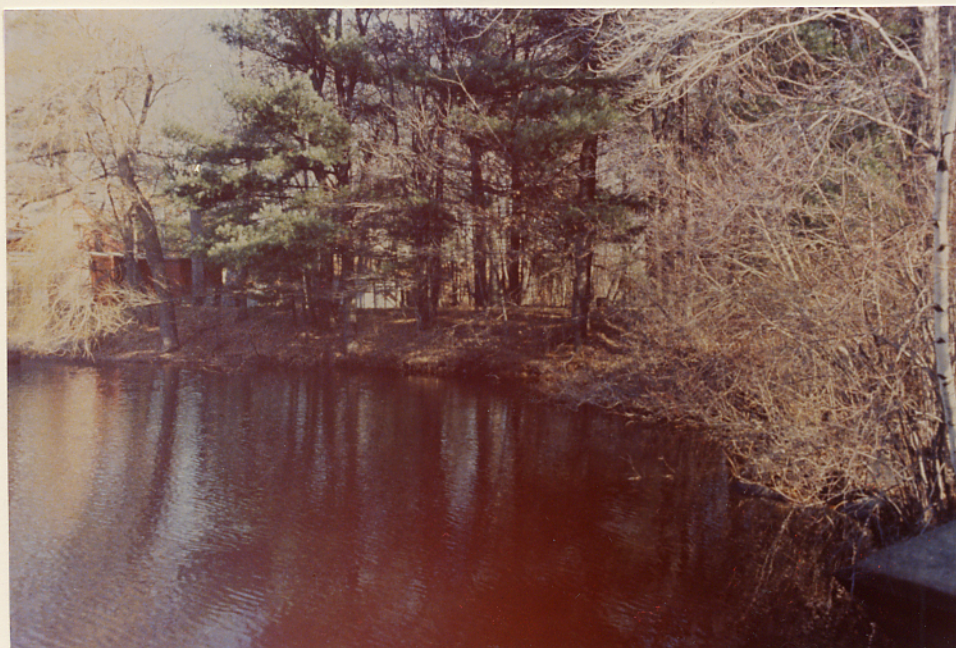
Rock Slope Protection - Riprap Failures	A few scattered pieces along U/S slope, some near U/S ends of both spillway tr. walls & some @ D/S end of outlet pipe.
Unusual Movement or Cracking at or near Toes	None visible
Unusual Embankment or Downstream Seepage	Large pool of water between outlet pipe & spillway at D/S toe; seepage at D/S toe on lt. embankment, one just lt. of spillway & second area south of cabin.
Piping or Boils	None visible
Foundation Drainage Features	None visible
Toe Drains	None visible
Instrumentation System	None visible

NO. 6 VIEW OF UPSTREAM EAST SLOPE OF DAM

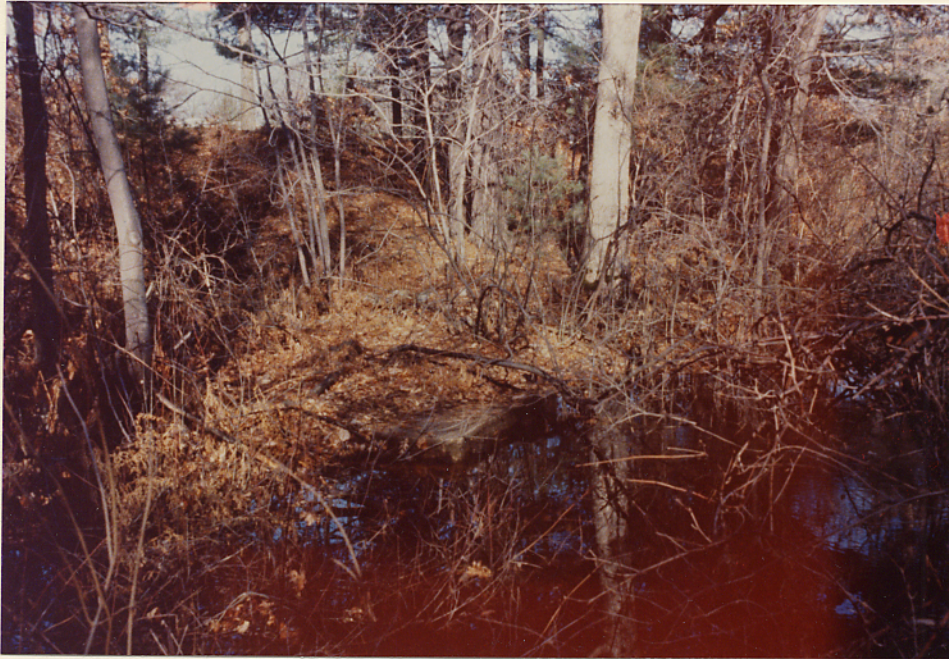
AREA EVALUATED	CONDITION
<u>OUTLET WORKS - OUTLET STRUCTURE AND OUTLET CHANNEL</u>	Concrete headwall at D/S toe protrudes beyond embankment, 24 inch diameter cast iron pipe discharges from headwall. Pipe*
General Condition of Concrete	Fair
Rust or Staining	Some
Spalling	Slight spalling on sides.
Erosion or Cavitation	None visible
Visible Reinforcing	None
Any Seepage or Efflorescence	None
Condition at Joints	N/A
Drain Holes	N/A
Channel	Streambed is part of an inundated swamp.
Loose Rock or Trees Overhanging Channel	Mostly bushes with some small trees along ill defined channel.
Condition of Discharge Channel	Submerged, limited visibility. Fair, with some dead trees.

NO. 7 VIEW OF OUTLET CONDUIT

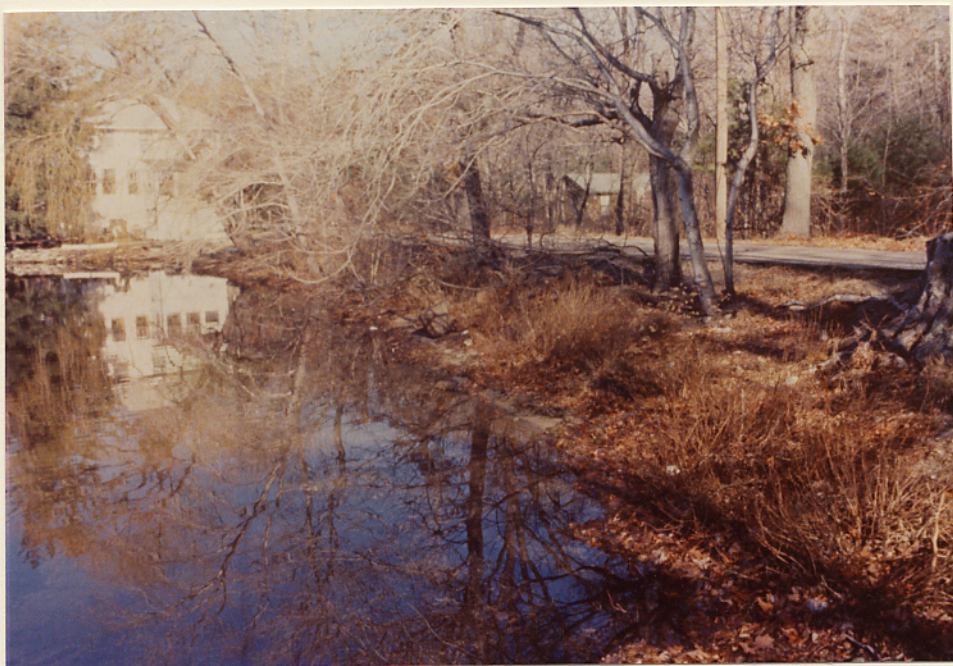
The earth dike is 800 feet long, 7 feet high and begins about 50 feet south of the main dam. In general, the dike is in fair condition. The crest of the dike is paved with asphalt and provides access to several houses located on both sides of Taylor Road. The upstream and downstream slopes of the dike are generally covered with brush and trees. There is seepage along most of the downstream toe of the dike. The surface of the water seeps varies from El 157.1 at the southern end of the dike to El 156.6 near the middle, to El 155.9 at the northern end. Some of the seepage water is flowing northward in a ditch along the toe of the dike. The seepage water eventually flows into the swamp downstream of the main dam. There is no riprap protection on the upstream slope of the dike.

NO. 8 VIEW OF UPSTREAM SLOPE OF DIKE
